# Road Safety Audit

**WV-9**

Traver's Country Store to Dollar General  
Berkeley County, West Virginia

**December 12, 2018**

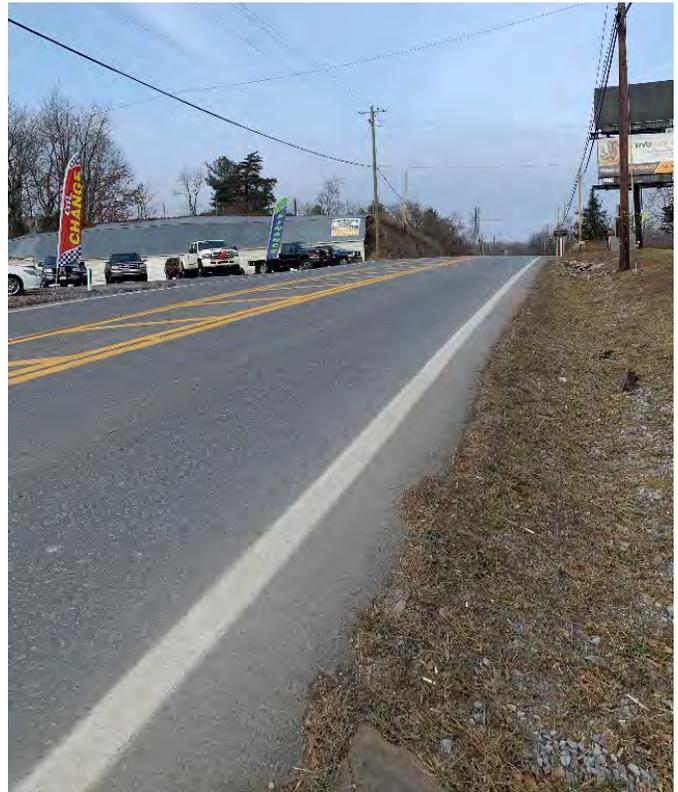
## 1.1 Vehicles Cresting Hills Too Fast

The general perception is that vehicles are cresting hills too fast for available sight distance.

Based on crash data from 2013 to 2017, 30% of the reported crashes within the study area occurred while cresting the hill near Traver's Country Store. 75% of which occurred during dry conditions

- Conduct speed study to reduce speed limit through 'village' area
- Advanced signing

- Realign and reprofile roadway
- Add turn/decel lanes
- Improve typical cross section to include paved shoulders

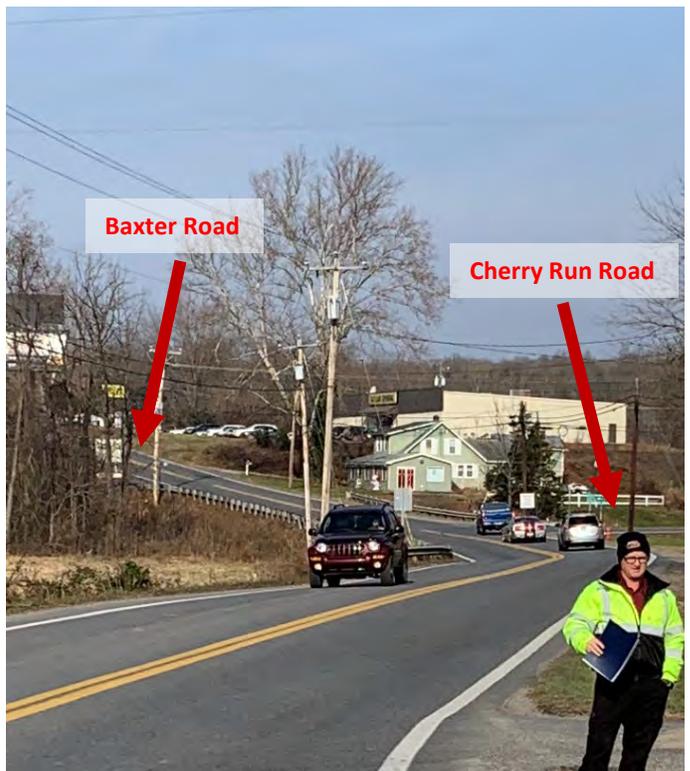
## 1.2 Slow Vehicles Entering and Exiting

Slow vehicles entering and exiting offset intersection of Baxter Road and Cherry Run Road create a safety concern due to sight distance constraints

Based on crash data from 2013 to 2017, 65% of the reported crashes along the corridor occurred in the vicinity of the offset intersection

- Conduct speed study to reduce speed limit through 'village' area
- Advanced intersection signing

- Add turn/decel lanes
- Improve typical cross section to include paved shoulders
- Realign and reprofile roadway

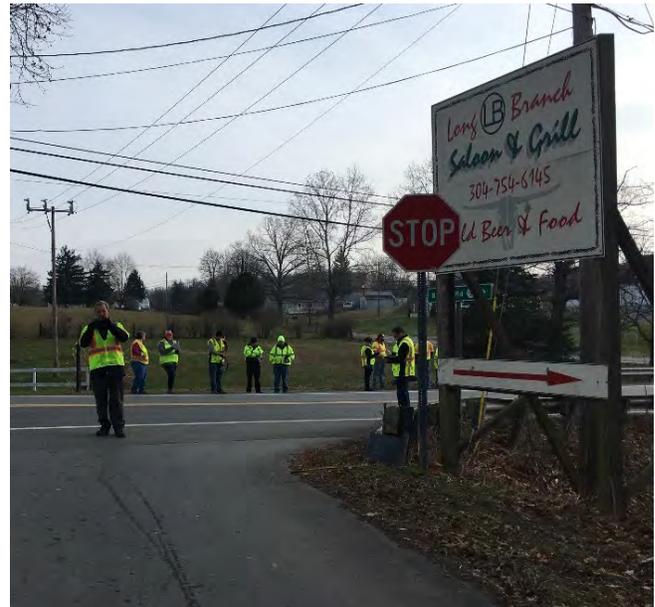
2.1 Baxter Road Intersection	
<b>Observations</b>	
Sight distance issue at Baxter Road intersection due to signs, vegetation and hedge	
Based on crash data from 2013 to 2017, 23% of the crashes along the corridor were angle crashes, 86% of which occurred in dry conditions.	
<b>Suggestions</b>	
<p><i>Short-term</i></p> <ul style="list-style-type: none"> <li>Relocate private advertising and directional signs</li> <li>Maintain vegetation overgrowth</li> </ul>

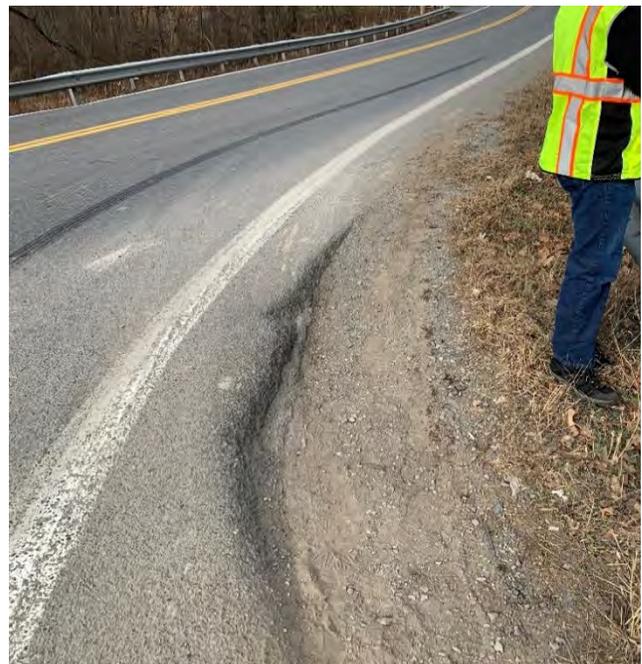
2.2 Cherry Run Road Intersection	
<b>Observations</b>	
Evidence of vehicles over-running pavement edges while entering and exiting Cherry Run Road intersections	
Picture shows the NW corner of the Cherry Run Road/WV-9 intersection	
<b>Suggestions</b>	
<p><i>Short-term</i></p> <ul style="list-style-type: none"> <li>Revise pavement markings</li> </ul> <p><i>Long-term</i></p> <ul style="list-style-type: none"> <li>Consider geometric improvements</li> </ul>

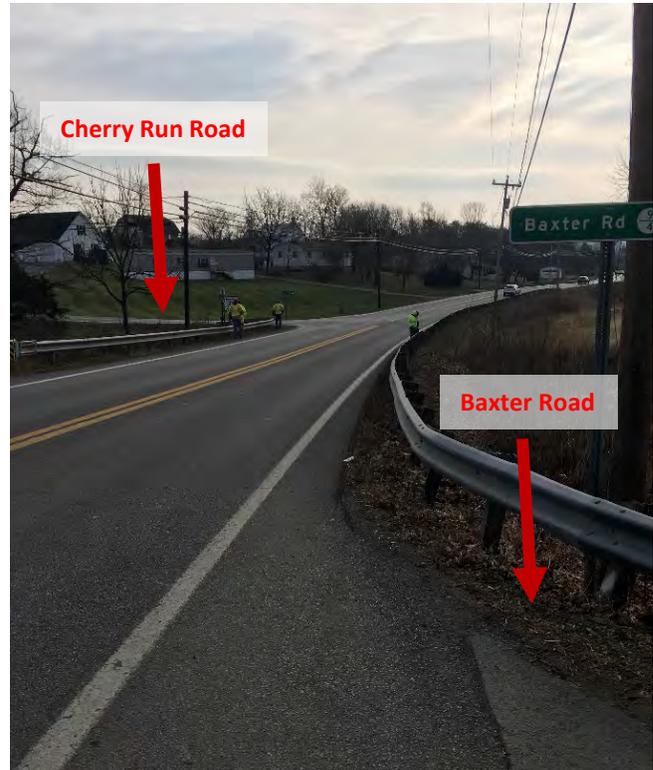
<b>2.3</b>	<b>Offset Intersection of Baxter Road and Cherry Run Road</b>
<b>Observations</b>	
<p>Slow vehicles entering and exiting offset intersection of Baxter Road and Cherry Run Road create a safety concern due to sight distance constraints.</p> <p>Based on crash data from 2013 to 2017, 65% of the reported crashes along the corridor occurred in the vicinity of the offset intersection</p>	
<b>Suggestions</b>	
<p><i>Short-term</i></p> <ul style="list-style-type: none"> <li>• Advance intersection signing</li> </ul> <p><i>Long-term</i></p> <ul style="list-style-type: none"> <li>• Add turn/decel lanes</li> <li>• Improve typical cross section to include paved shoulders</li> </ul>

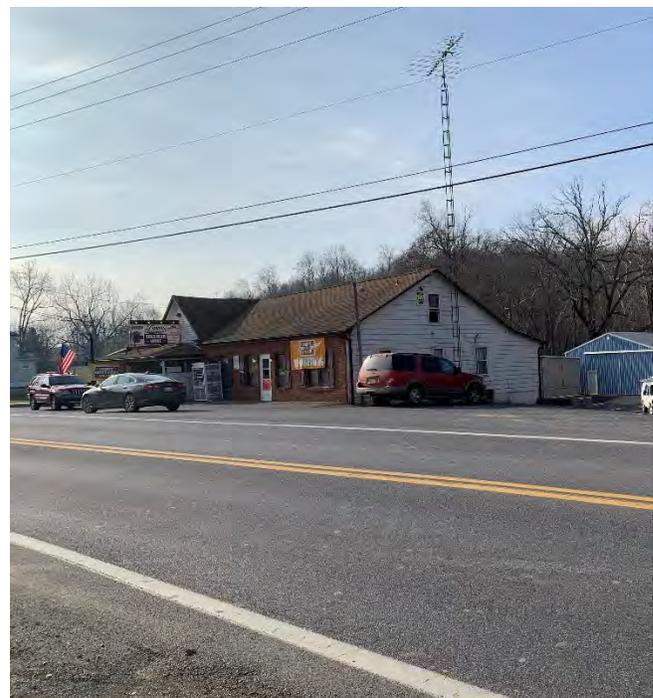
<b>3.1</b>	<b>Driveway/Parking Area for Traver's Country Store</b>
<b>Observations</b>	
<p>Driveway/parking area for Traver's Country Store is heavily utilized and unchanneled</p> <p>Photo of Traver's Country Store parking lot, facing westbound WV-9</p>	
<b>Suggestions</b>	
<p><i>Short-term</i></p> <ul style="list-style-type: none"> <li>• Work with property owner to provide traffic flow guidance</li> </ul> <p><i>Long-term</i></p> <ul style="list-style-type: none"> <li>• Realign and reprofile roadway thereby providing additional circulation/parking area in front of business</li> </ul>

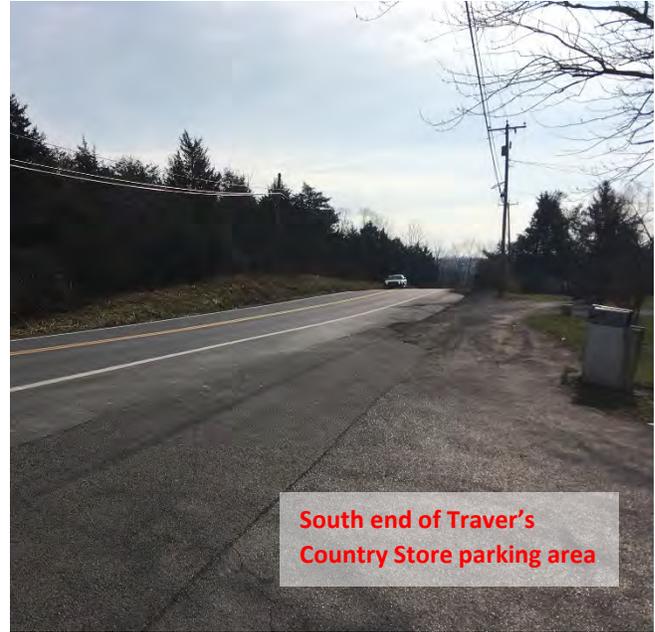
**3.2 Exiting/Entering from Unchanneled Parking Area**

Exiting/entering from southern end of unchanneled parking area has sight distance constraints due to vertical curve/hill on WV-9

Photo of Traver's Country Store parking lot, facing eastbound WV-9

- Work with property owner to provide traffic flow guidance

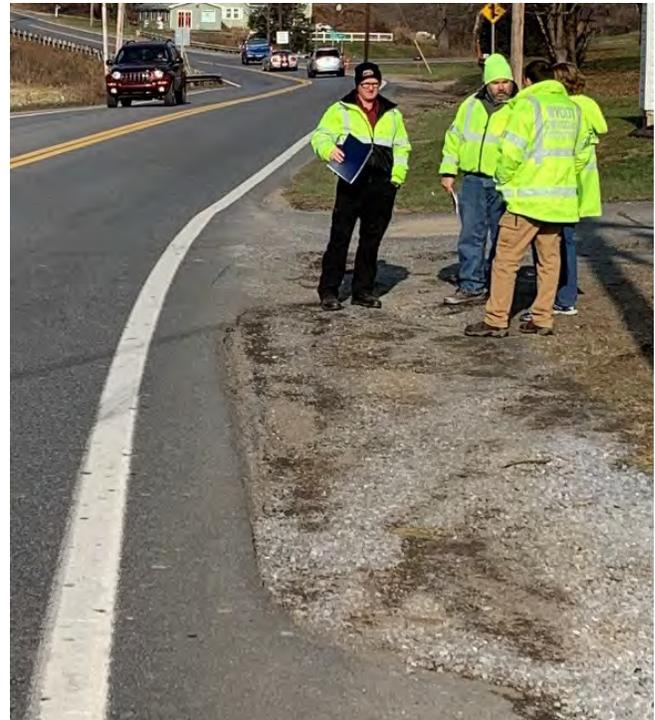
**3.3 Open Arms Ministry Driveway**

Driveway near 'Open Arms Ministry' has created a gravel/mud decel lane/large turning radius

Picture facing westbound WV-9 at 'Open Arms Ministry' driveway prior to the Cherry Run Road intersection

- Create stone shoulders

- Improve typical cross section to include paved shoulders

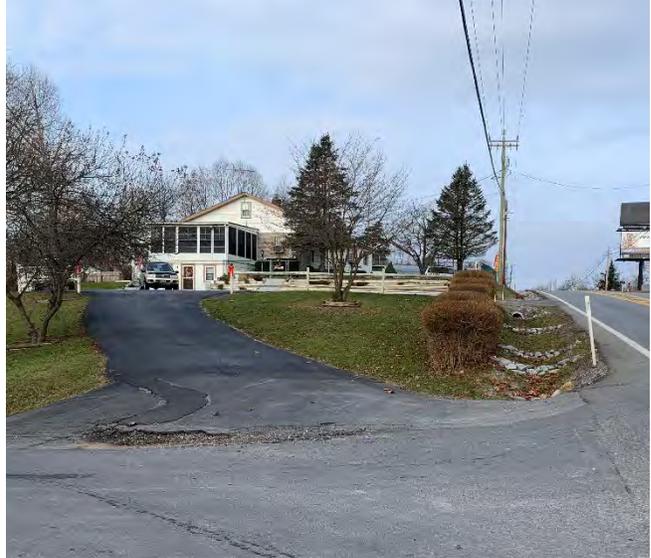
<b>3.4</b>	<b>Residential Driveway in Radius of Baxter Road Intersection</b>
<b>Observations</b>	
Residential driveway located in radius of Baxter Road intersection	
<b>Suggestions</b>	
<p><i>Long-term</i></p> <ul style="list-style-type: none"> <li>Relocate residential driveway</li> </ul>

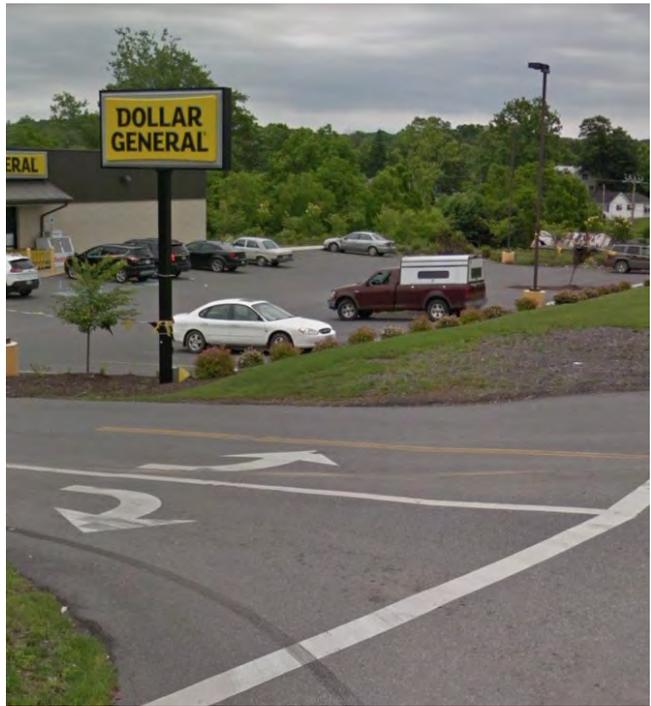
<b>3.5</b>	<b>Driveway to Dollar General</b>
<b>Observations</b>	
Driveway to Dollar General has two exit lanes which may create mutual sight distance obstruction when used concurrently	
<b>Suggestions</b>	
<p><i>Short-term</i></p> <ul style="list-style-type: none"> <li>Conduct traffic counts and consider revising pavement markings to a 1-lane exit</li> </ul>

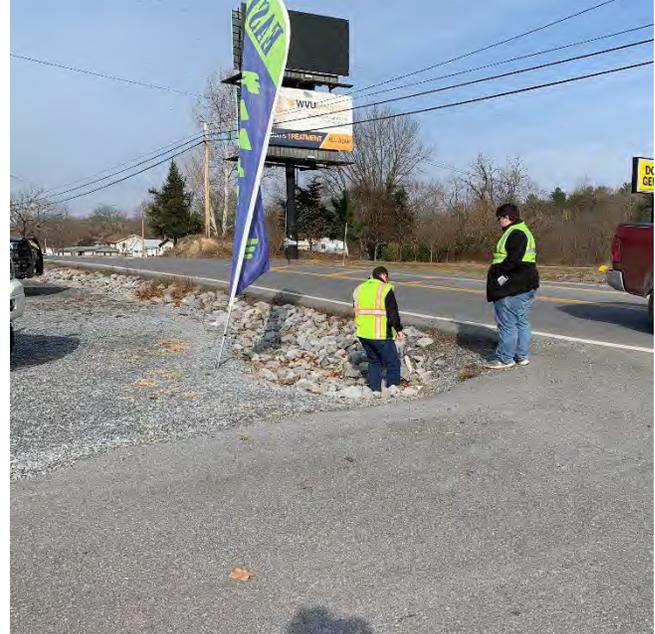
**3.6 Country Side Auto Sales Driveway**

Driveway to 'Country Side Auto Sales' has sight distance constraint due to vertical curve/hill

- Improve typical cross section to include paved shoulders
- Realign and reprofile roadway

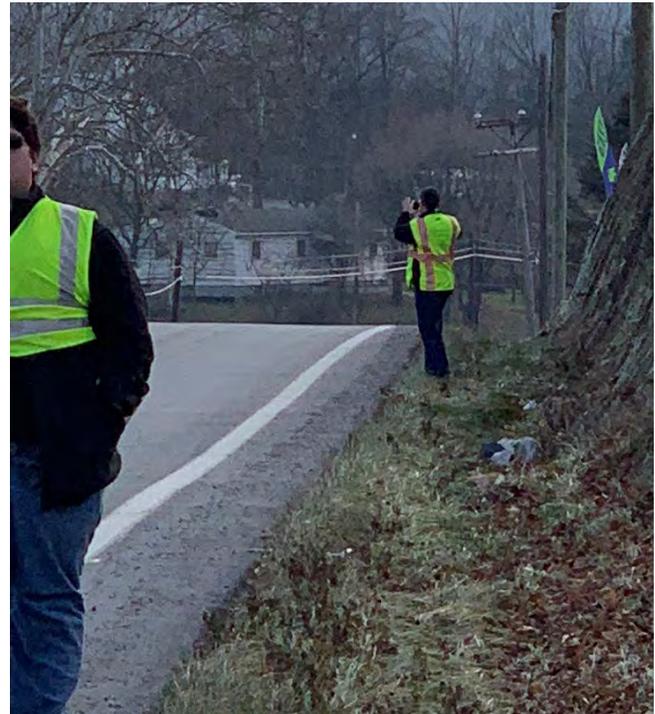
1.1	Sight Distance Constraints
<b>Observations</b>	
Study area located between two vertical curves (hills) with sight distance constraints	
The picture shows eastbound WV-9 as it approaches the study area	
<b>Suggestions</b>	
<i>Short-term</i>	
<ul style="list-style-type: none"> <li>• Add advanced intersection signing</li> <li>• Speed and sight distance study to reduce speed limit</li> </ul>	
<i>Long-term</i>	
<ul style="list-style-type: none"> <li>• Realign and reprofile roadway</li> </ul>

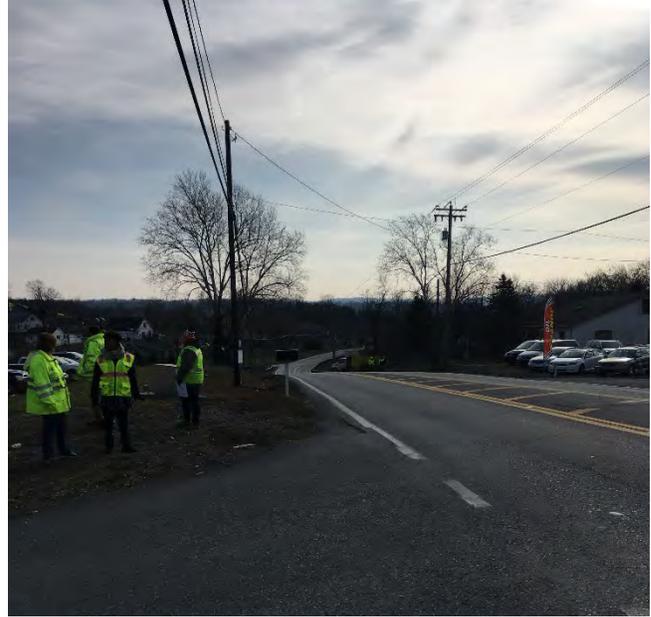
<b>1.2</b>	<b>No/Minimal (1'-4') Shoulders</b>
<b>Observations</b>	
<p>Two 12' lanes with no/minimal (1'-4') shoulders</p> <p>Based on crash data from 2013 to 2017, 30% of the reported crashes within the study section were single vehicle, sideswipe, or head on crashes. 75% of the single vehicle crashes hit a fixed object (pole, tree, guardrail, embankment)</p>	
<b>Suggestions</b>	
<p><i>Long-term</i></p> <ul style="list-style-type: none"> <li>• Improve typical cross section to include paved shoulders</li> </ul>

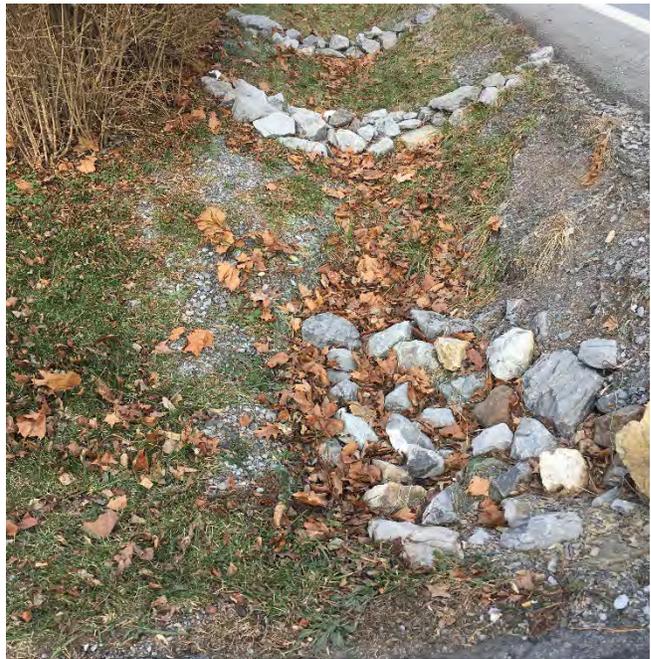
<b>2.1</b>	<b>Drainage Issues at Baxter Run Road Intersection</b>
<b>Observations</b>	
<p>Drainage issues at Baxter Run Road intersection</p> <p>Picture shows drainage along WV-9, west of the Baxter Run Road intersection</p>	
<b>Suggestions</b>	
<p><i>Long-term</i></p> <ul style="list-style-type: none"> <li>• Drainage/pipe/swale improvements</li> <li>• Relocate residential driveway</li> </ul>

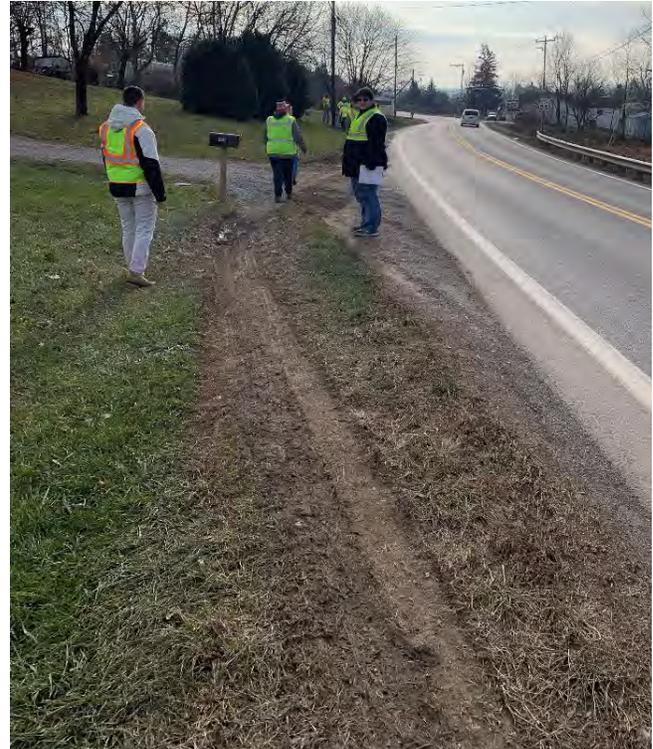
**2.2 Mailboxes Close to Roadway Edge**

A few mailboxes are close to the roadway edge – causing mail delivery vehicle to stop in the roadway for mail deliveries. Other mailboxes have evidence of dirt/mud mail truck tire tracks off of the pavement edge.

- Coordinate uniform mailbox placement and add 'shoulder' surface (stone) for mail delivery vehicle

- Improve typical cross section to include paved shoulders

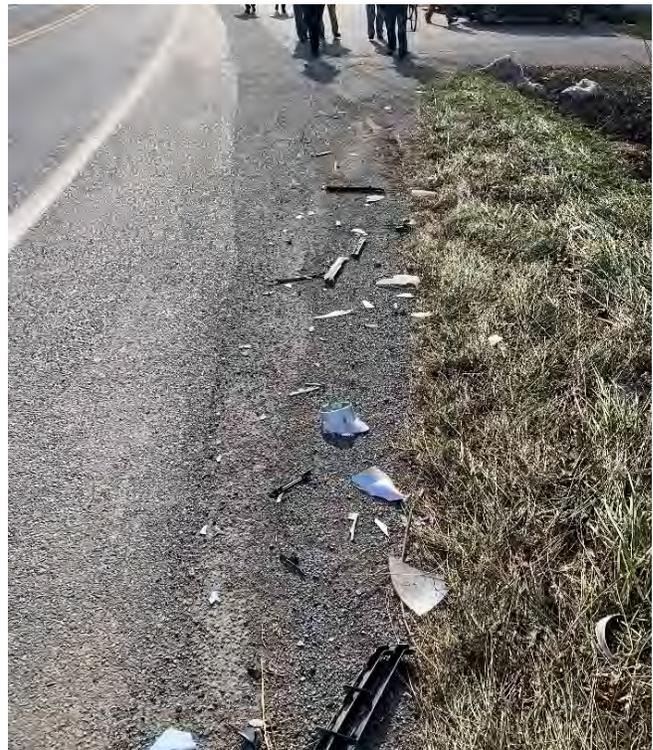
**2.3 Evidence of Crashes**

Evidence of many crashes (vehicle parts/crash debris along roadside) throughout the study section

The corridor crash rate for this section of roadway is 547 crashes per 100 million VMT. Picture shows eastbound WV-9 just prior to Traver's Country Store parking lot

Implement various safety improvements recommendations as noted here-in

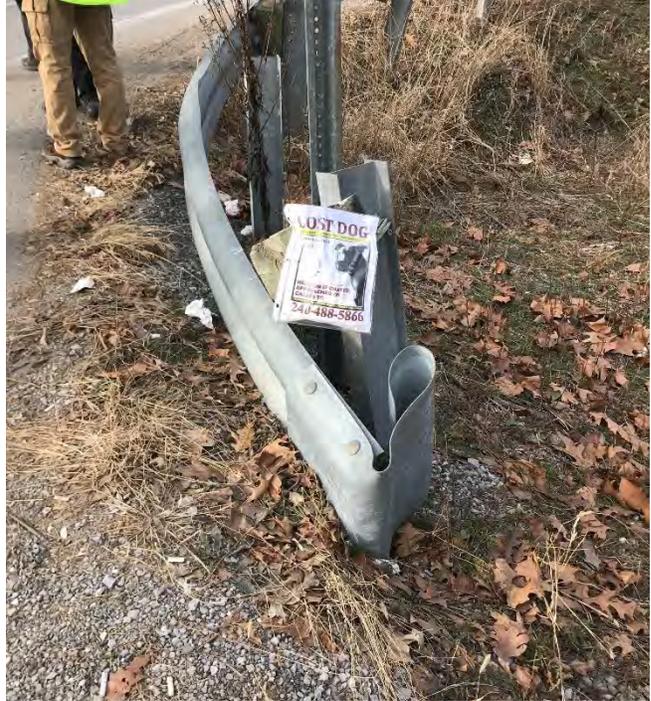
**2.4 Missing Guiderail Object Markers**

Guiderail along roadway at Cherry Run Road intersection is missing object markers at all ends except one. It also has no delineators

Guiderail pictured is at the Cherry Run Road intersection. Additional evidence of cars scraping against guiderail

- Install object markers
- Install delineators

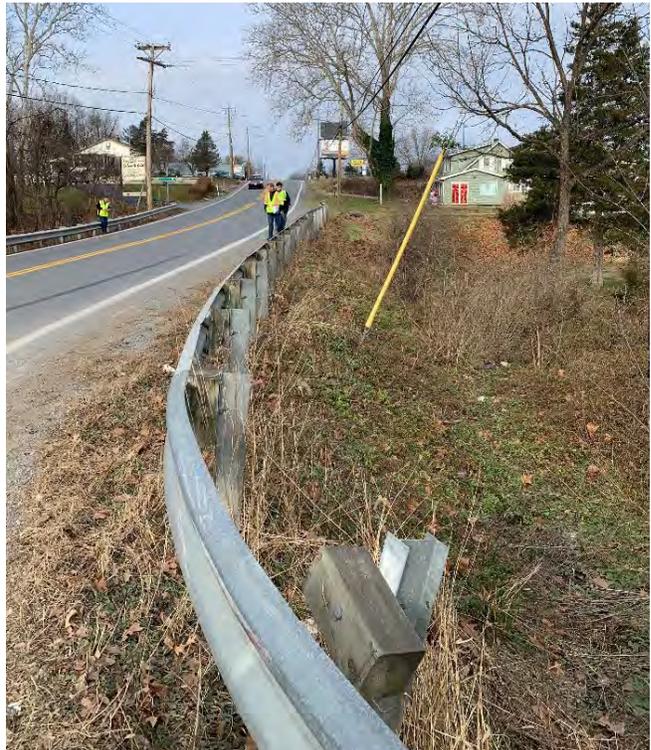
**2.5 Guiderail at Cherry Run Road**

Guiderail end facing Cherry Run Road approach detached from supports

Evidence of crash or over-running. Picture shows guiderail along NW corner of the Cherry Run Road/WV-9 intersection.

- Install delineators
- Revise pavement markings

- Geometric improvements at intersection

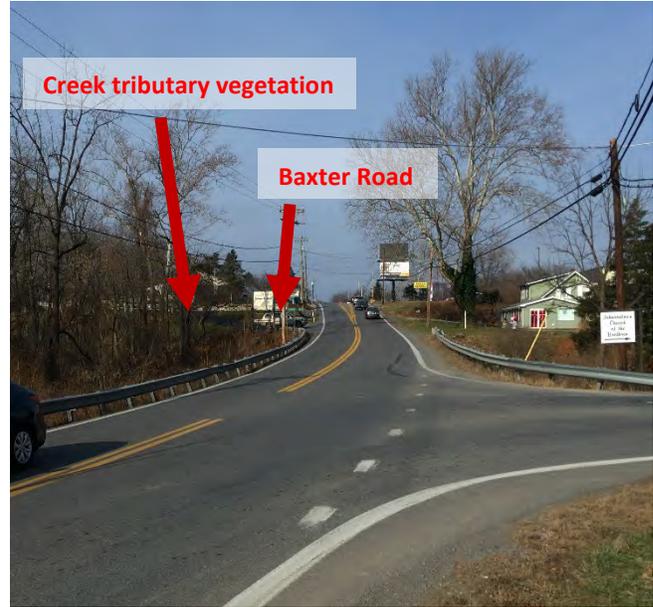
**2.6 Vegetation in Close Proximity to**

Vegetation in close proximity to roadway along creek (tributary) is not maintained. Anecdotal evidence suggests this makes a sight distance obstruction for Baxter Rd in growing season.

Address vegetation trimming through regular maintenance

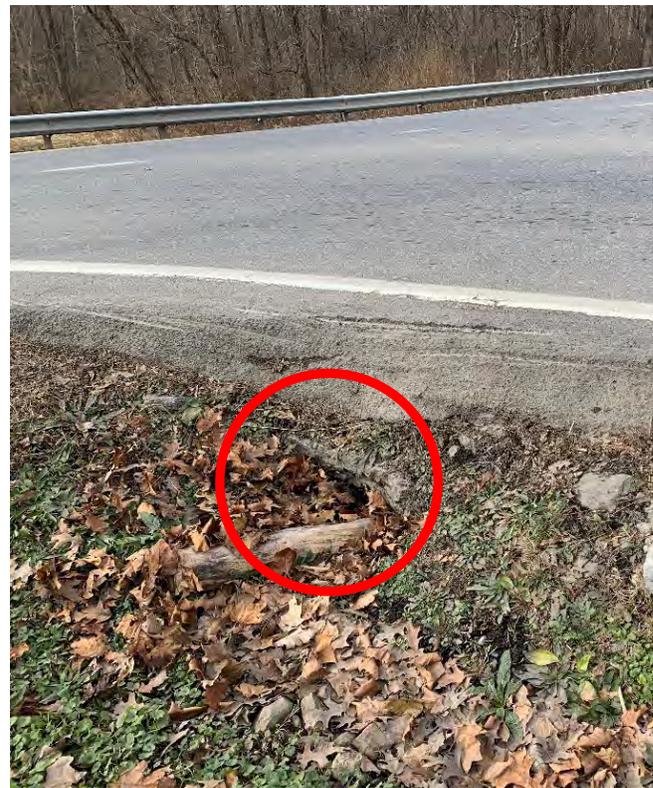
**2.7 Drainage Pipe and Swale at Cherry Run Road Intersection**

Drainage pipe and swale at Cherry Run Road intersection at very edge of pavement. Unprotected pavement edge shows evidence of vehicle scraping

Picture shows pavement edge of NE corner of the Cherry Run Road/WV-9 intersection.

- Add maintenance markers/delineators
- Revise pavement markings

- Extend pipe and drainage ditch configuration and install shoulders
